## TEST REPORT

Report No.: KR-10-00401X

Product Description: Toggle Switch  
Style/ Item No.: FE-A1770, FE-A1771, FE-A1772, FE-A1773, FE-A1774, FE-A1775, FE-A1776,  
FE-A1777  
Manufacturer/ Vendor: Function Electric Inc.  
Quantity: Total 8 pieces  
Received Date: September 28, 2010  
Date of Testing: September 30, 2010

Test Required: (According to client's test specification, please see following sheets in detail.)  
1. IPX7 Waterproof Test

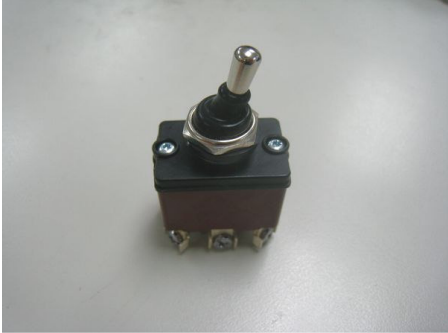
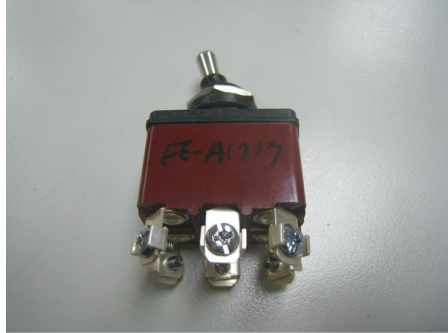
1. Appearance of specimens before test	2. Appearance of specimens before test

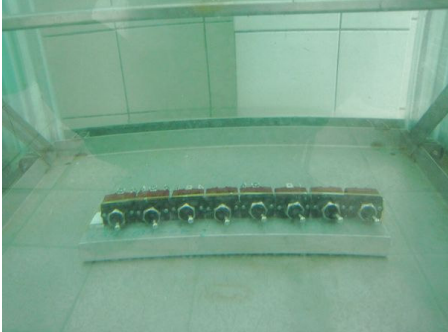
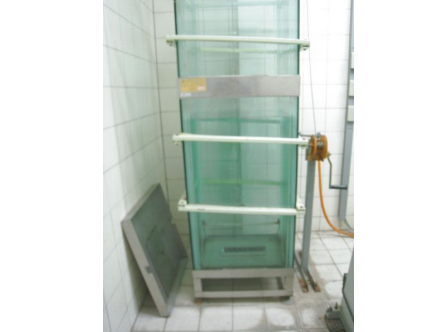
Test condition: The lowest point of enclosures is located 1000 mm below the surface of the water

Test duration: 30 minutes

3. IPX7 waterproof test condition	4. IPX7 waterproof test condition
